The Royal Ship of Cheops

A retrospective account of the
discovery, restoration and
reconstruction.

Paul Lipke

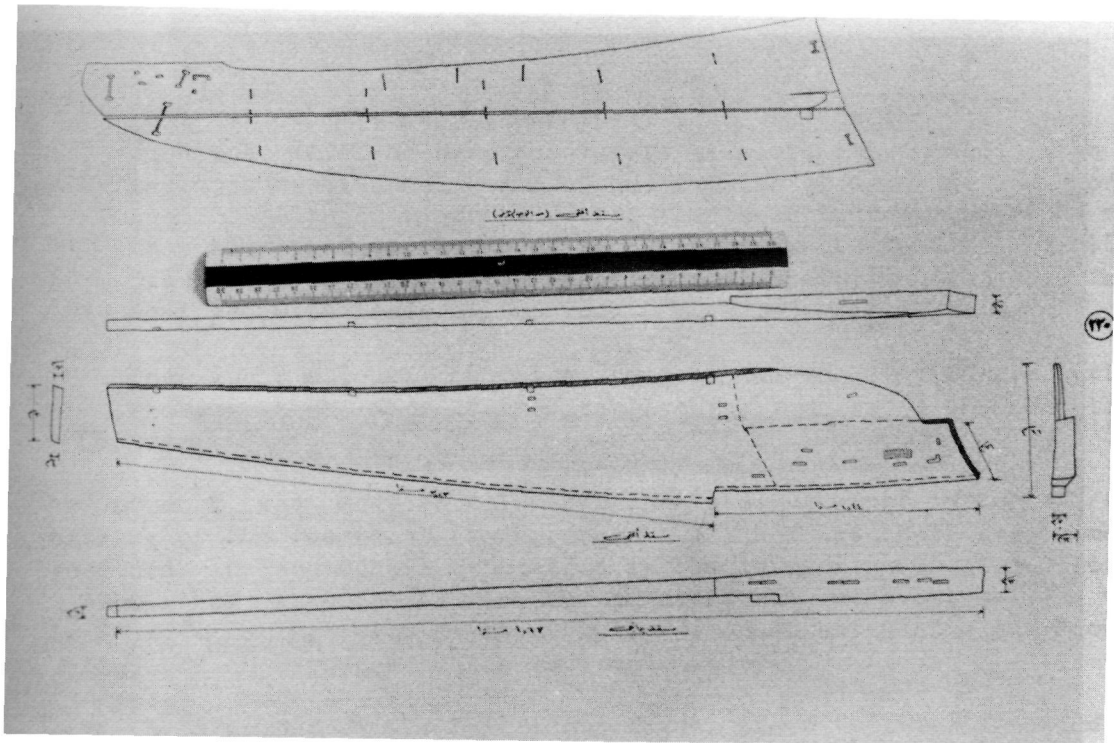
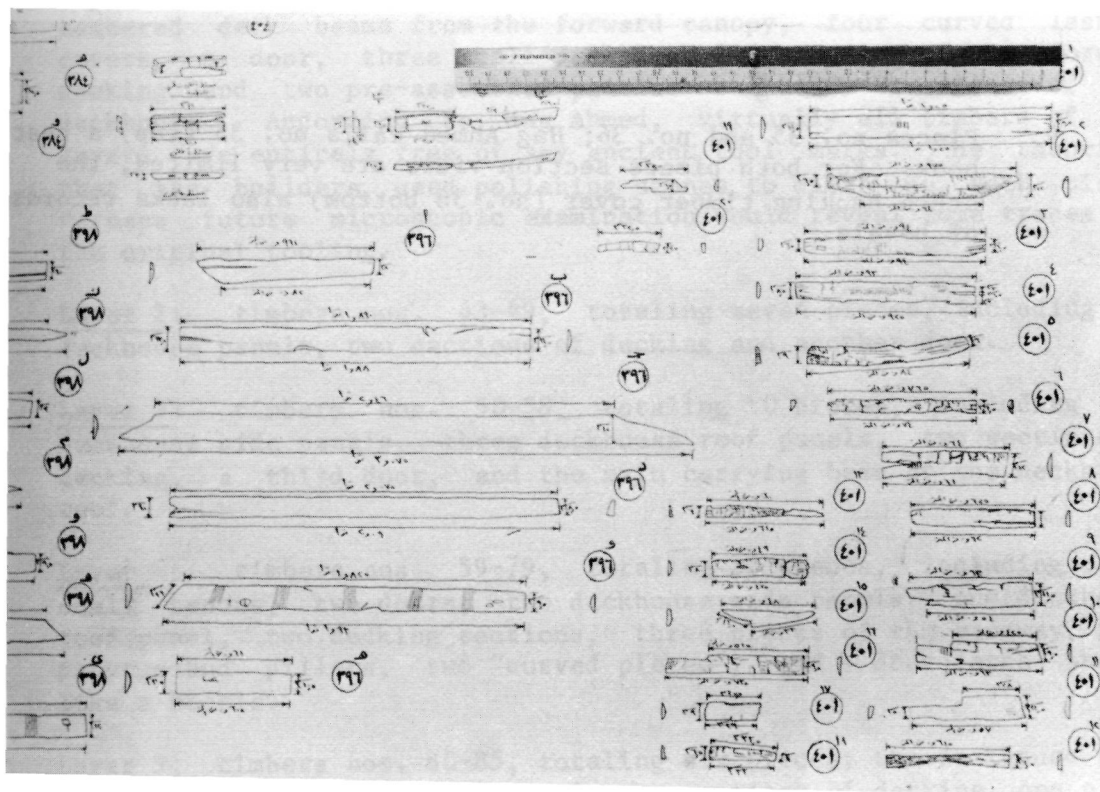
8. a) Piece 220, the bow port backing timber shown in four views with a profile of its cover above.
- b) Miscellaneous damaged battens and stanchions.

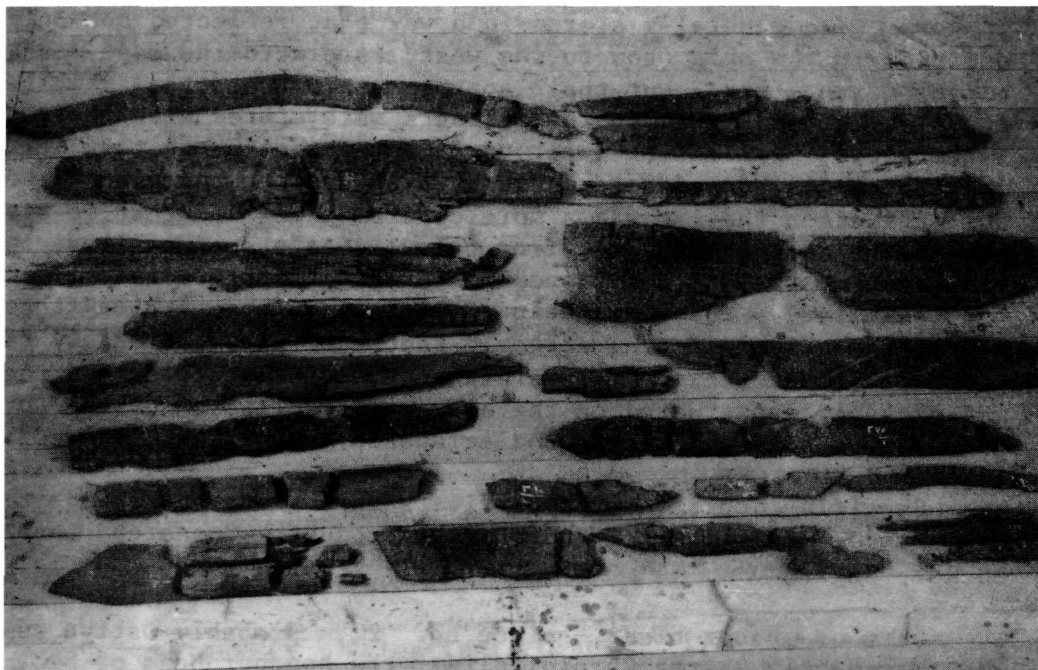
14. Desiccated battens; wide ones at right covered scarfs and plank ends.

<u>ITEMS</u>	<u>PHOTOS</u>	<u>NATURE OF DAMAGE</u>	<u>THEORY OF CAUSE</u>	<u>RESTORED</u>	<u>REPLICATED</u>
for'd canopy	N.A.	roof cracked at aft end	desiccation/shrinkage	X	
13 deck beams	Fig. 34	checked and/or marbled at ends, a few were fragmented at their ends	desiccation, poor storage in the cases of fragmentation	10	3
side longitudinal girder	N.A.	cracked vertically near centre	none	X	
garboard at stem to starboard	Fig. 31	checked around a knot	desiccation/shrinkage	X	
spine	N.A.	cracked	desiccation/shrinkage	X	
4 lash-ing covers	Fig. 13	marbled slightly, broken	desiccation	X	
16 frames	Fig. 36	cracked and fragmented	desiccation	16	
11 oars	Fig. 22, 23,	marbled and fragmented	desiccation	10	1
6 backing timber covers	Fig. 24	marbled and fragmented	desiccation plus poor storage	X	
deckhouse panels	N.A.	checked at ends of planks	desiccation plus poor storage	X	
battens (number unspecified)	Fig. 14	marbled, fragmented	desiccation plus poor storage	some	some

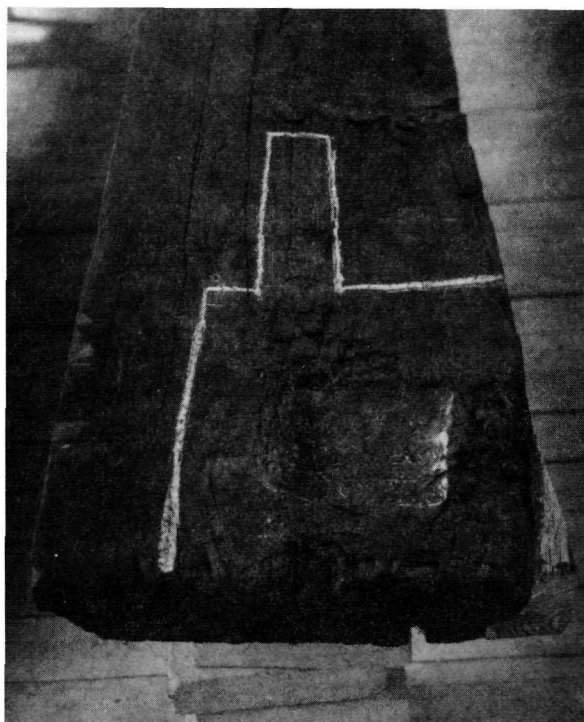
18. Damaged bottom plank with compressed area from support blocking and desiccation. Area to be removed outlined in chalk.

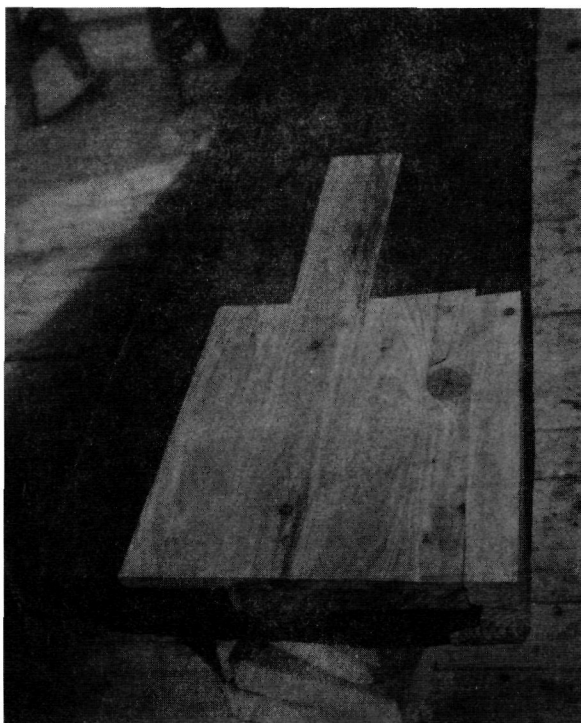
19. Four separate ennab subsections in place and planed fair.

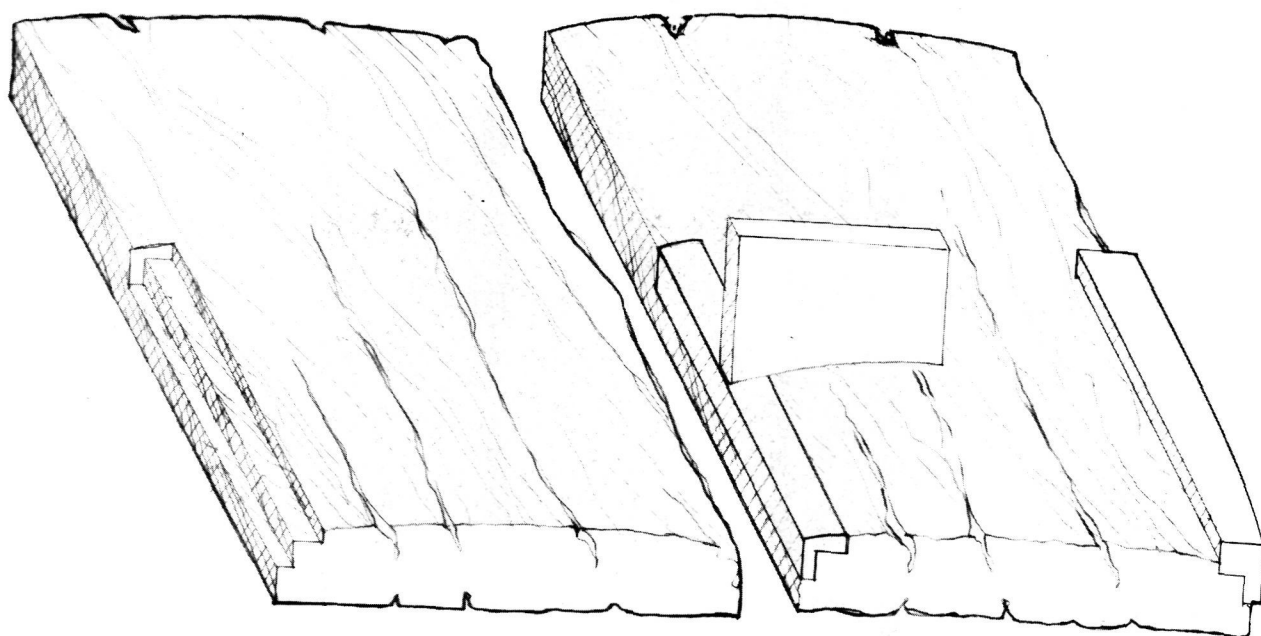
20. Detail of patching method 2 which preserves dimensions of complex pieces. Peter Schmid/Paul Lipke.

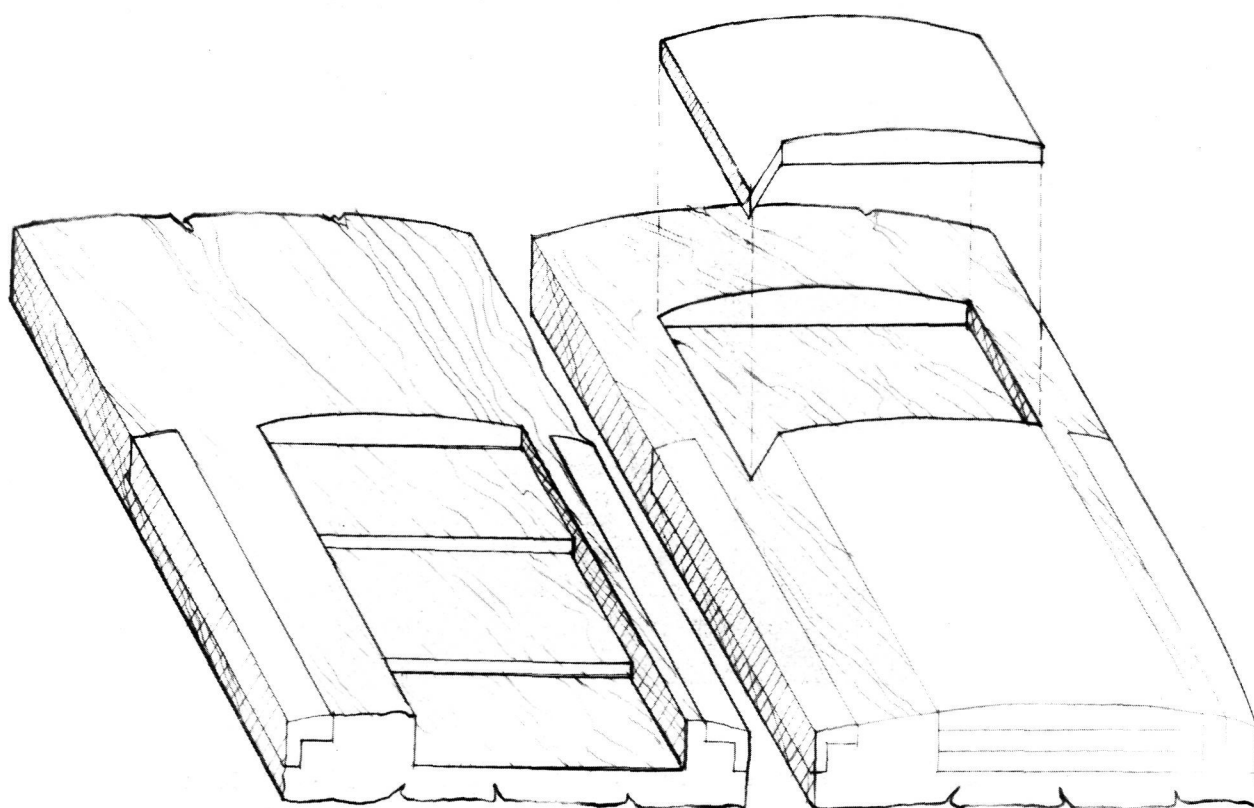
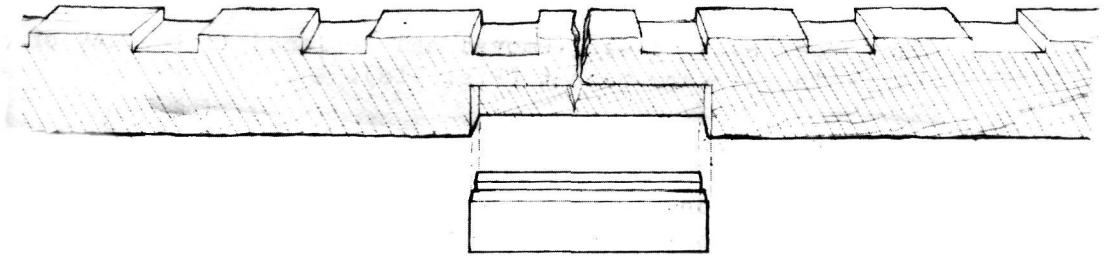
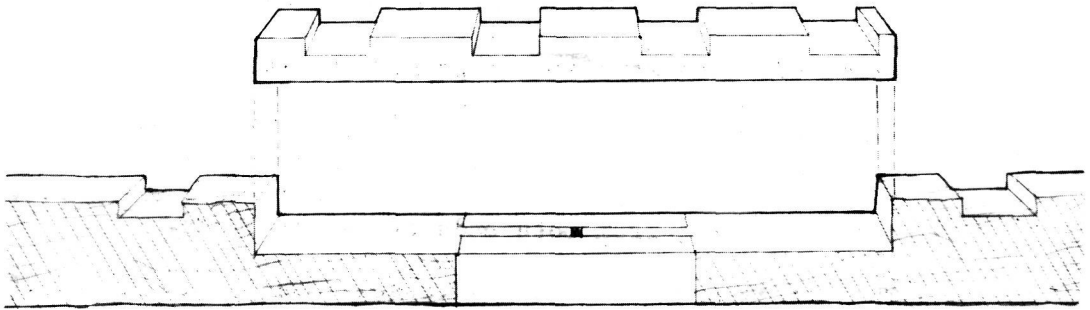
21. Detail of patching method 3 for structural weak points. Peter Schmid/Paul Lipke.

Large timbers with structural weak points, such as the cracked spine were also repaired with ennab section.³⁶

- A. A section of the surface area around the crack was removed from both sides of the timber (Fig. 21a).

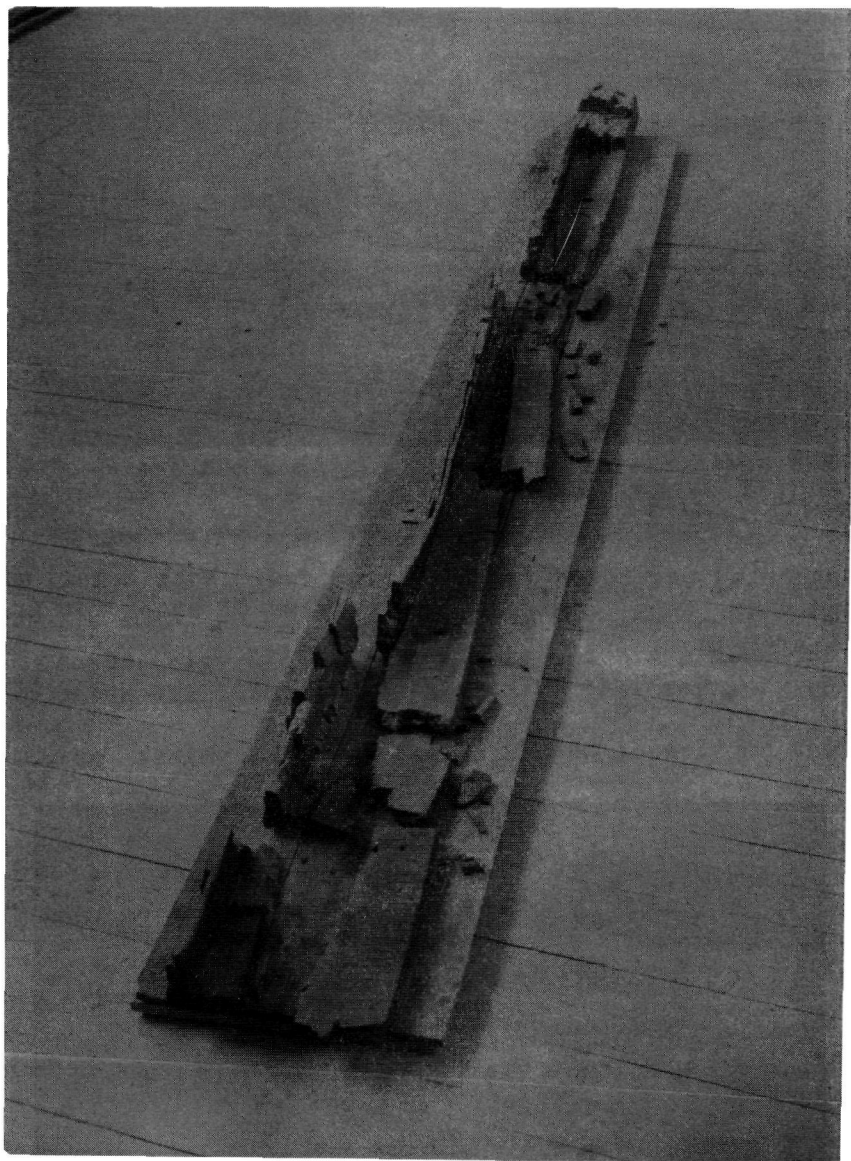
24. Fragmented, forward port upper backing timber cover.
Note part of mortise for stem post at top.

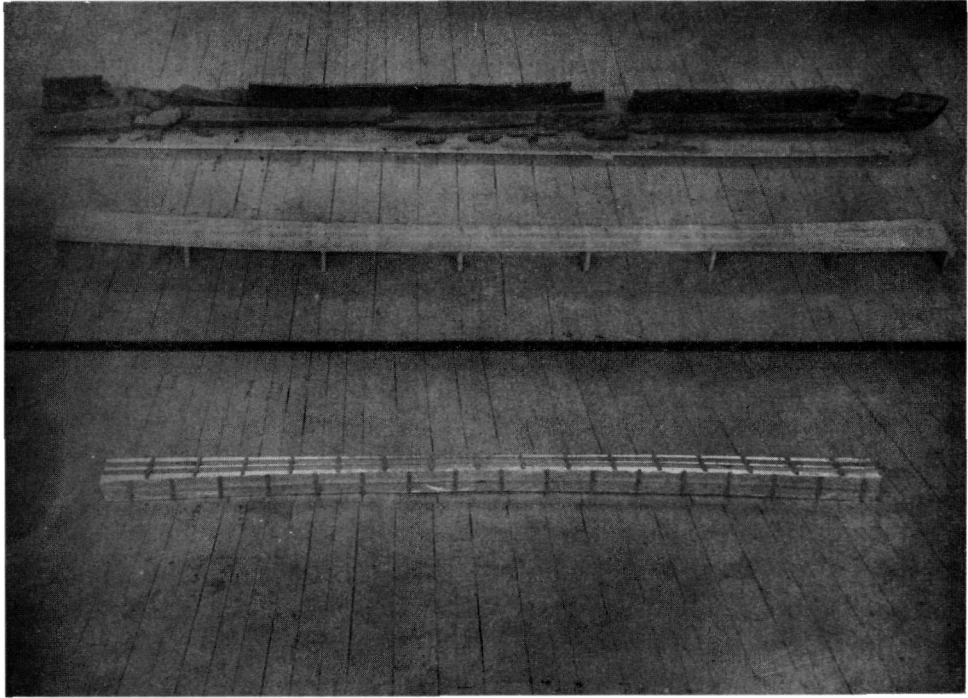
25. Backing timber covers; fragments (top), bare mould at centre, mould with ennab grid and aluminium foil covering at bottom.

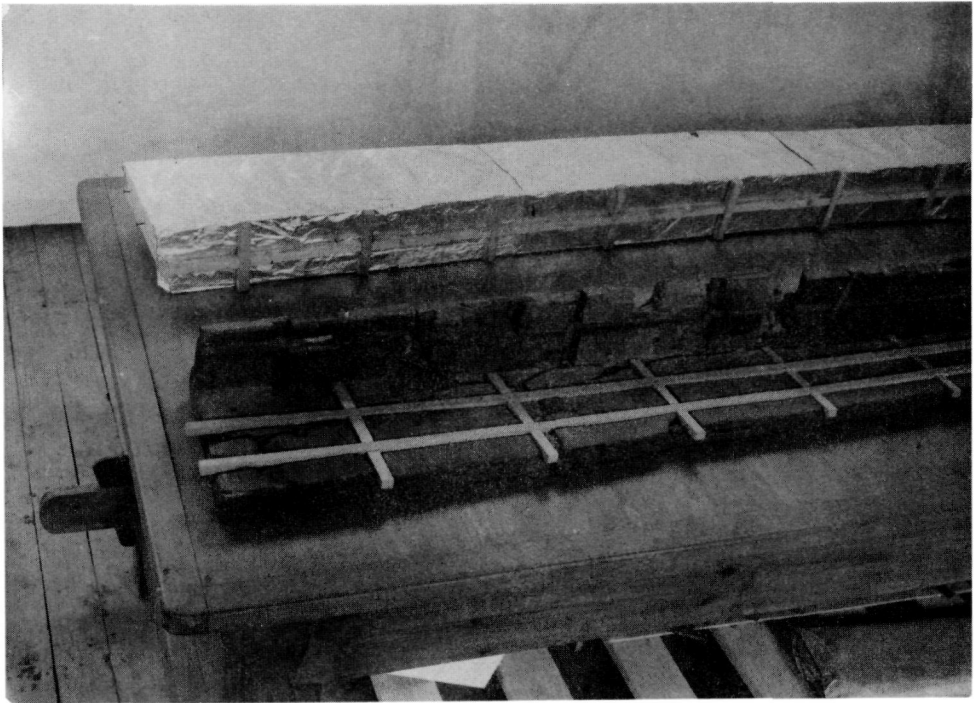
27. Backing timber covers; ennab grid glued to fragments with mould removed.

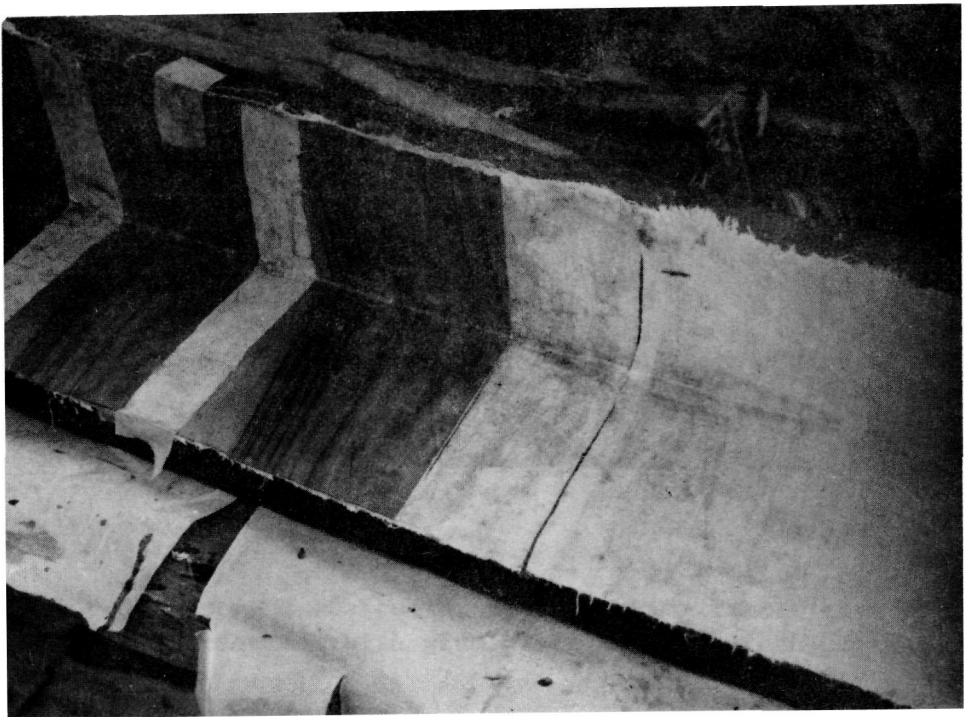
28. Backing timber cover; cotton fabric backing at right, first layer of veneers at left.

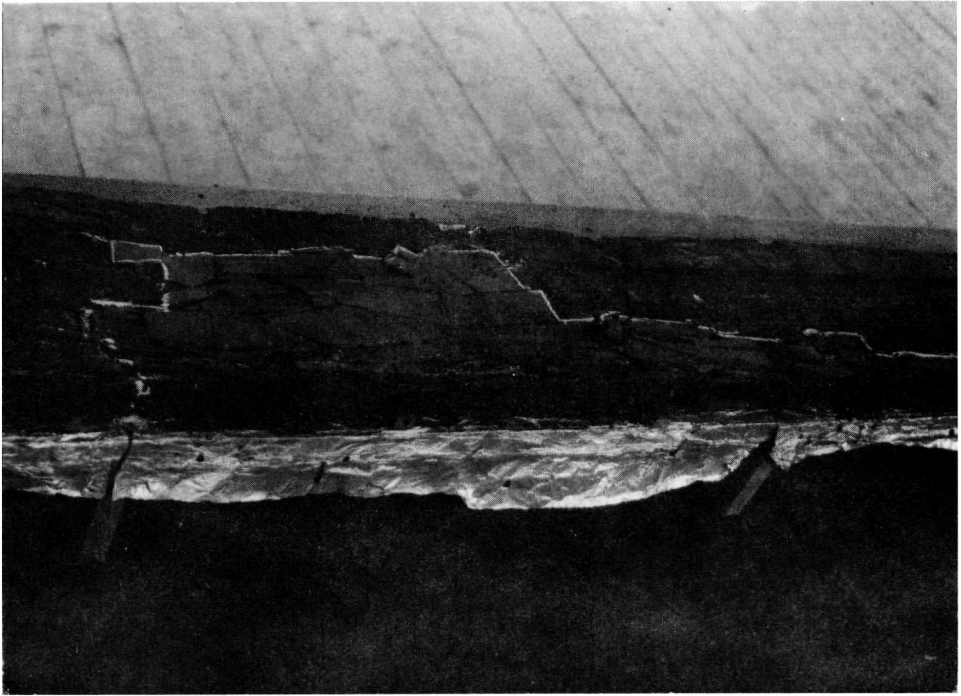
29. Backing timber covers; small fragments with "enmeshed edges" outlined in chalk. The cover has been placed over the mould again for support.

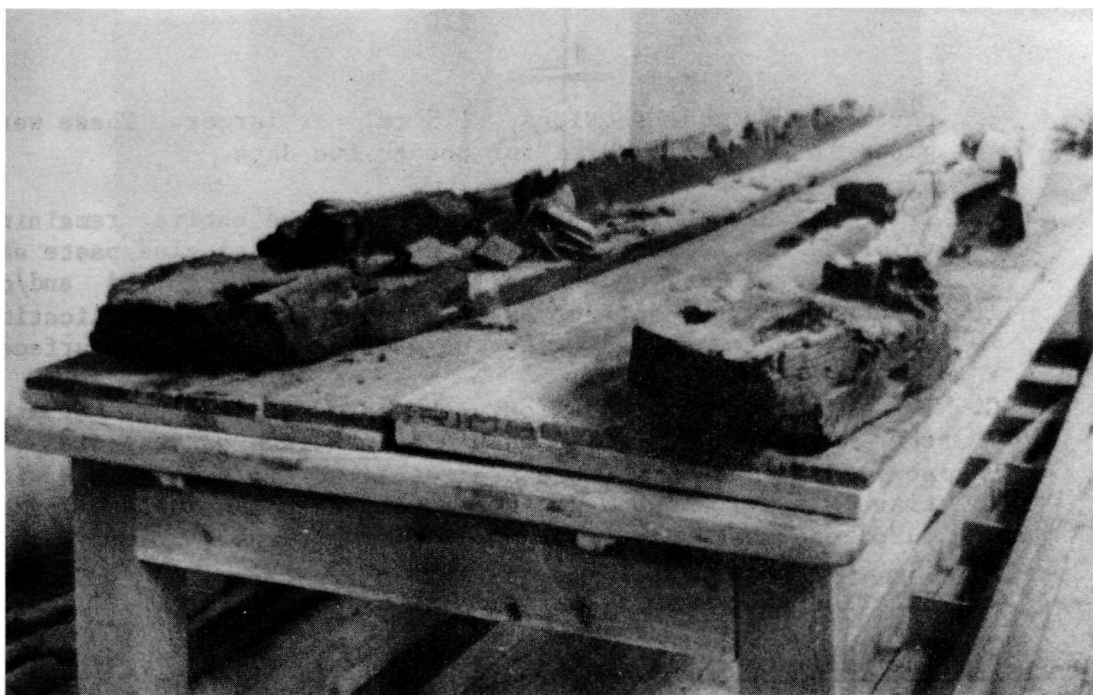
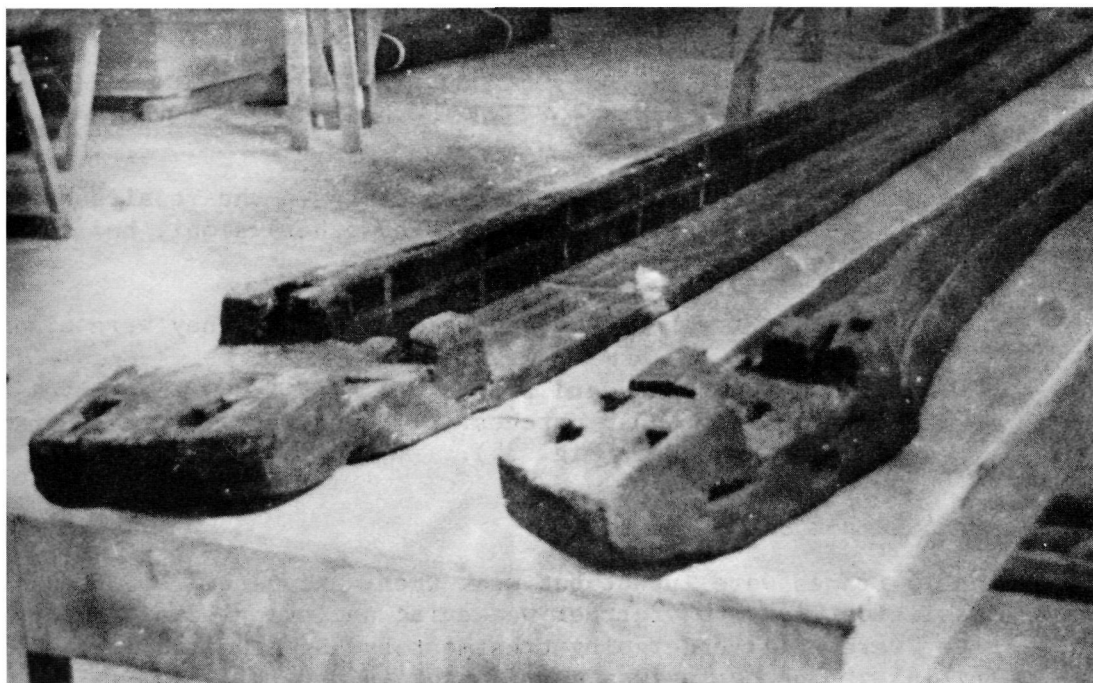
30. Forward, port and starboard, upper backing timber covers before and after treatment with glue paste to strengthen mortise and fill checks.

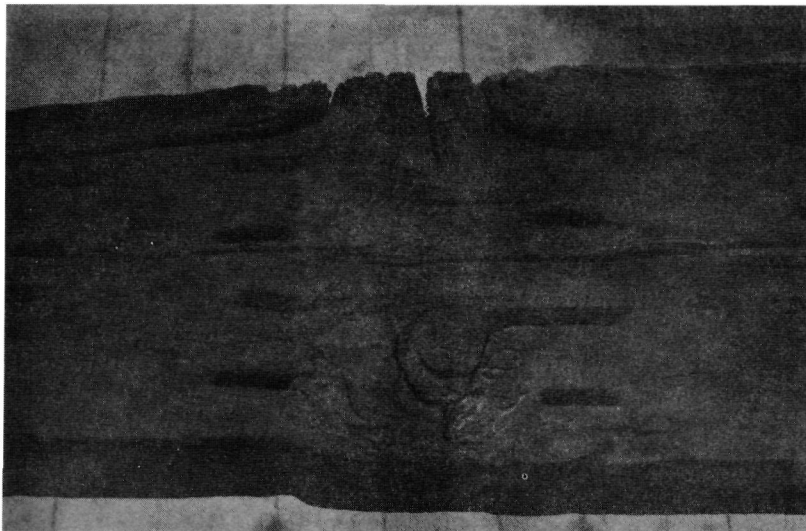
31. Garboard plank with 2 slash knots opposite each other detailing curved checking and the way these knots tended to pull the plank apart.

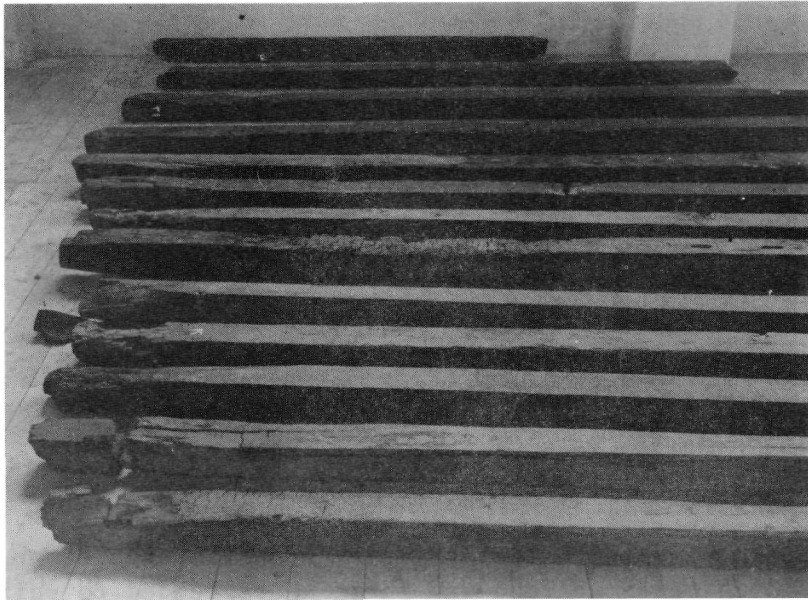
34. 13 damaged deck beams showing tendency for desiccation to be more severe at ends.

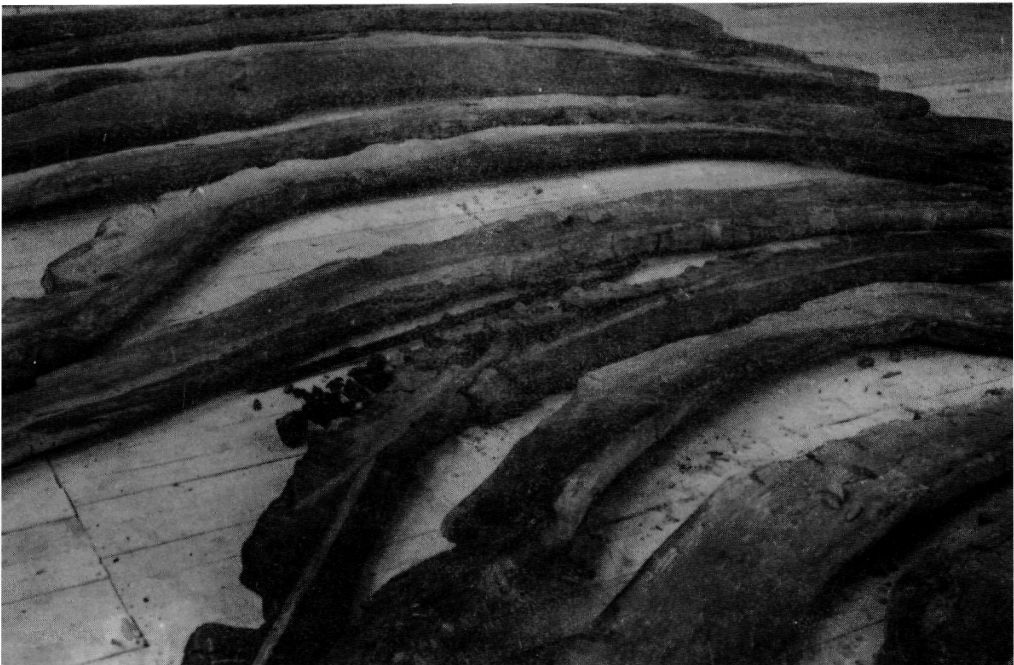
36. Damaged frames; the earlier spline repairs are clearly visible at centre. Note the irregularity of the notches for the seam battens.

- A. A square or dovetail sectioned channel was cut out of the fore and aft faces of the frame. An ennab spline was then fitted and glued in place (Fig. 36).
- B. Especially weak points were sandwiched between two dutchmen as in Patching Method "3".
- C. Repairs to later, more extensive problems often necessitated the use of dutchmen and/or numerous dowels (Figs. 37a, 37b, 37c).

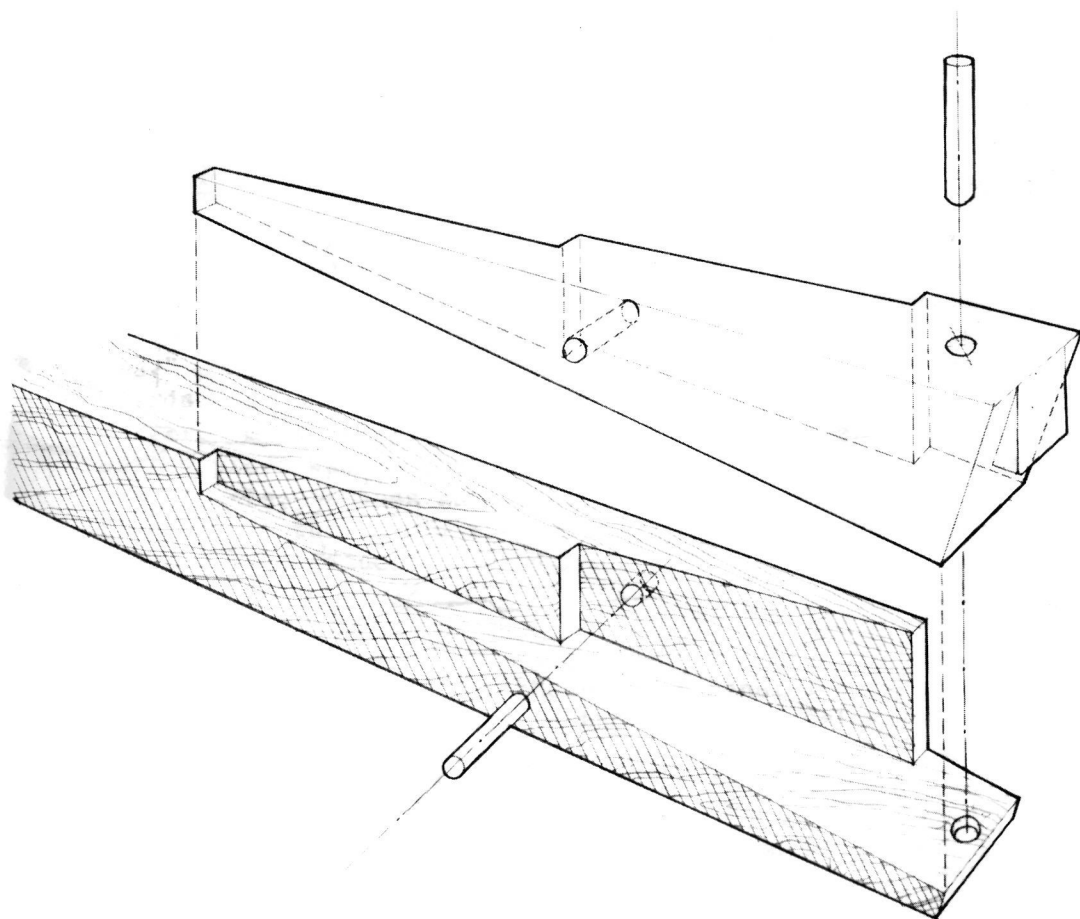
35. Exploded view of a deck beam repair showing hook scarfs and pegs. Note also bevelled tenon at right for mortise in sheer strake. Peter Schmid/Paul Lipke.

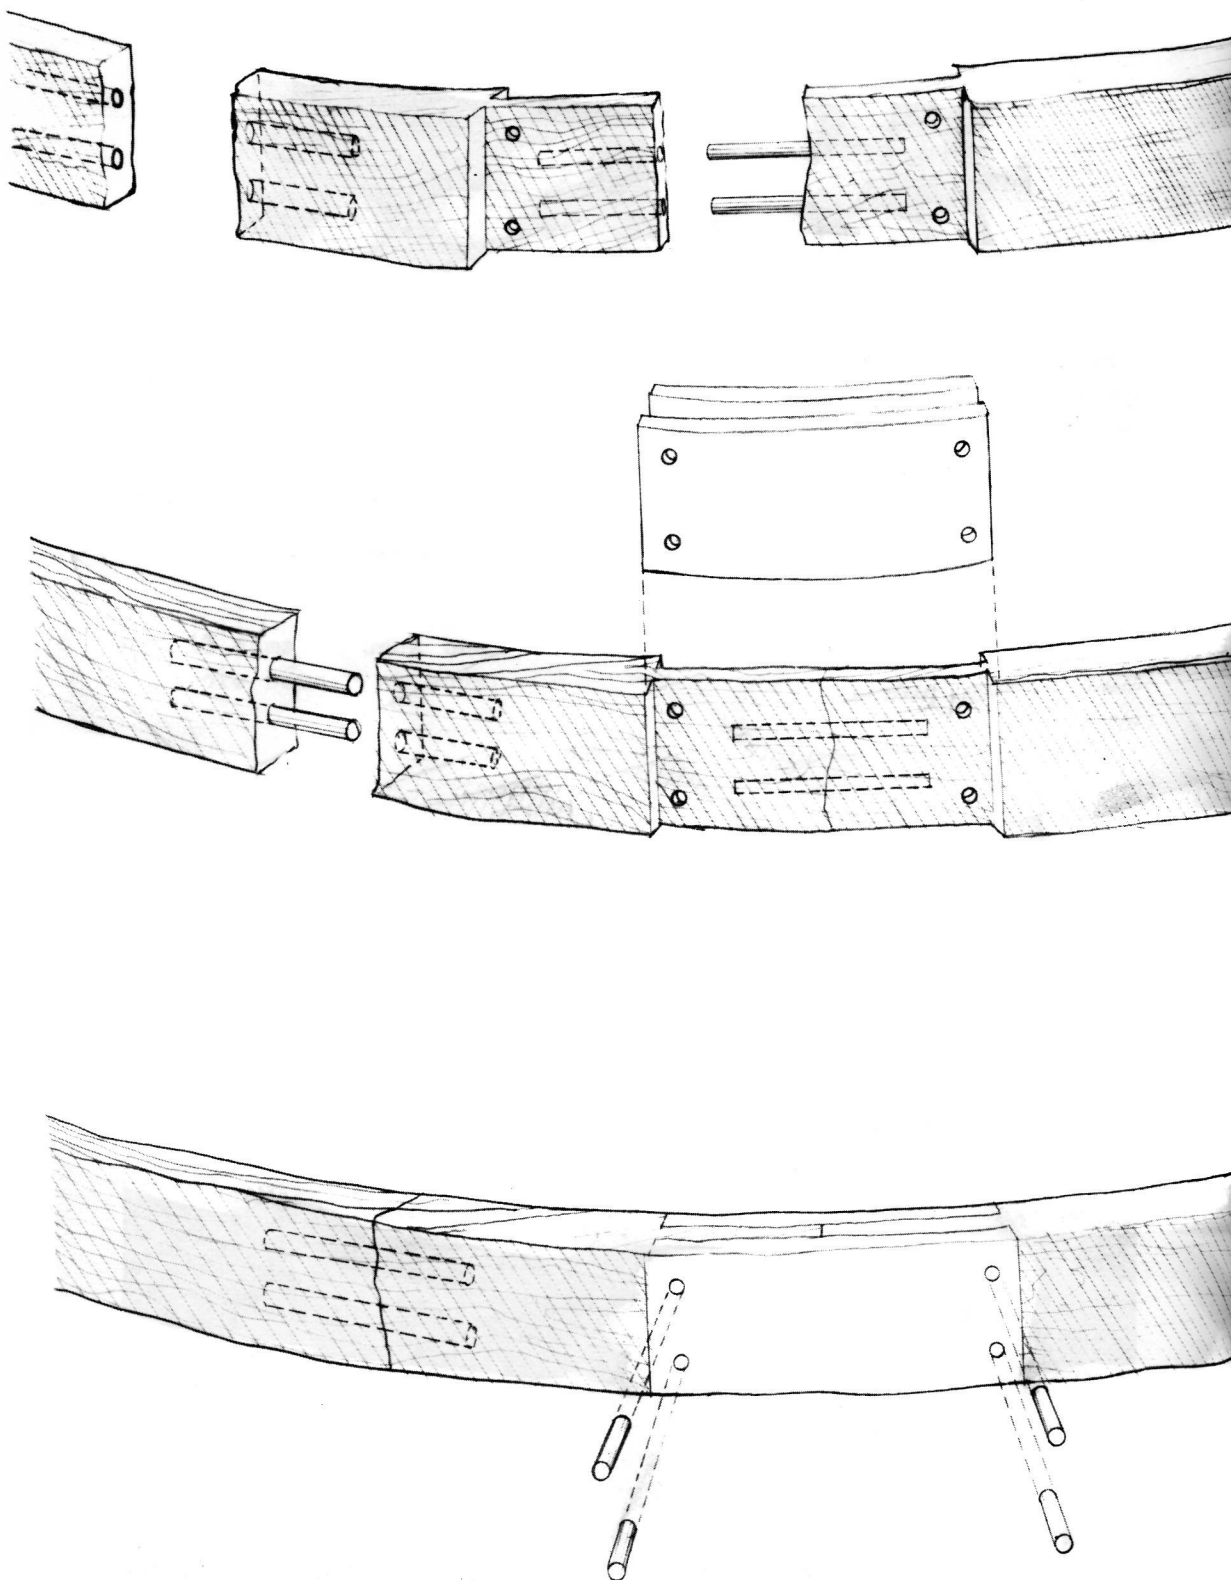
37. Fragments treated by pinning and reinforcement with dutchmen.
Peter Schmid/Paul Lipke.

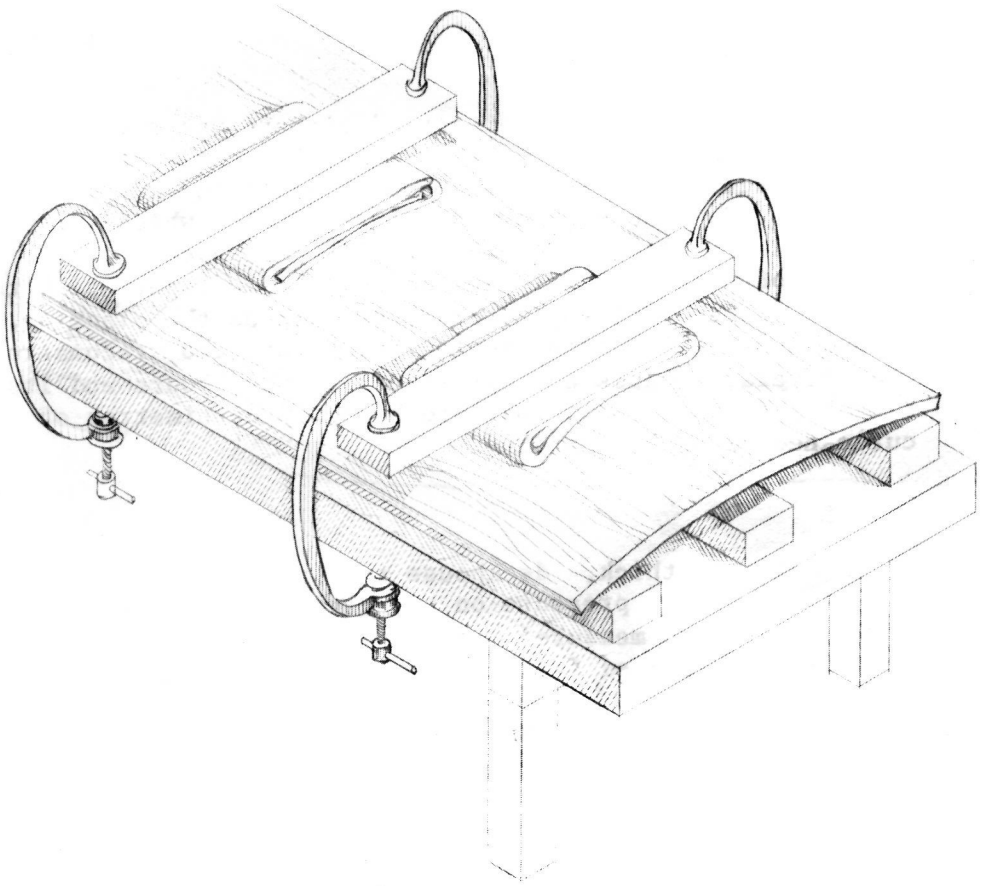
38. Cupped plank of a roof panel prepared for rebending with boiling water and controlled pressure. Peter Schmid/Paul Lipke.

- F. If the plank appeared to be strained at any point, several days "rest" might be inserted between each increase in pressure.
- G. In general, twist was corrected first, cupping second, and the curve last.

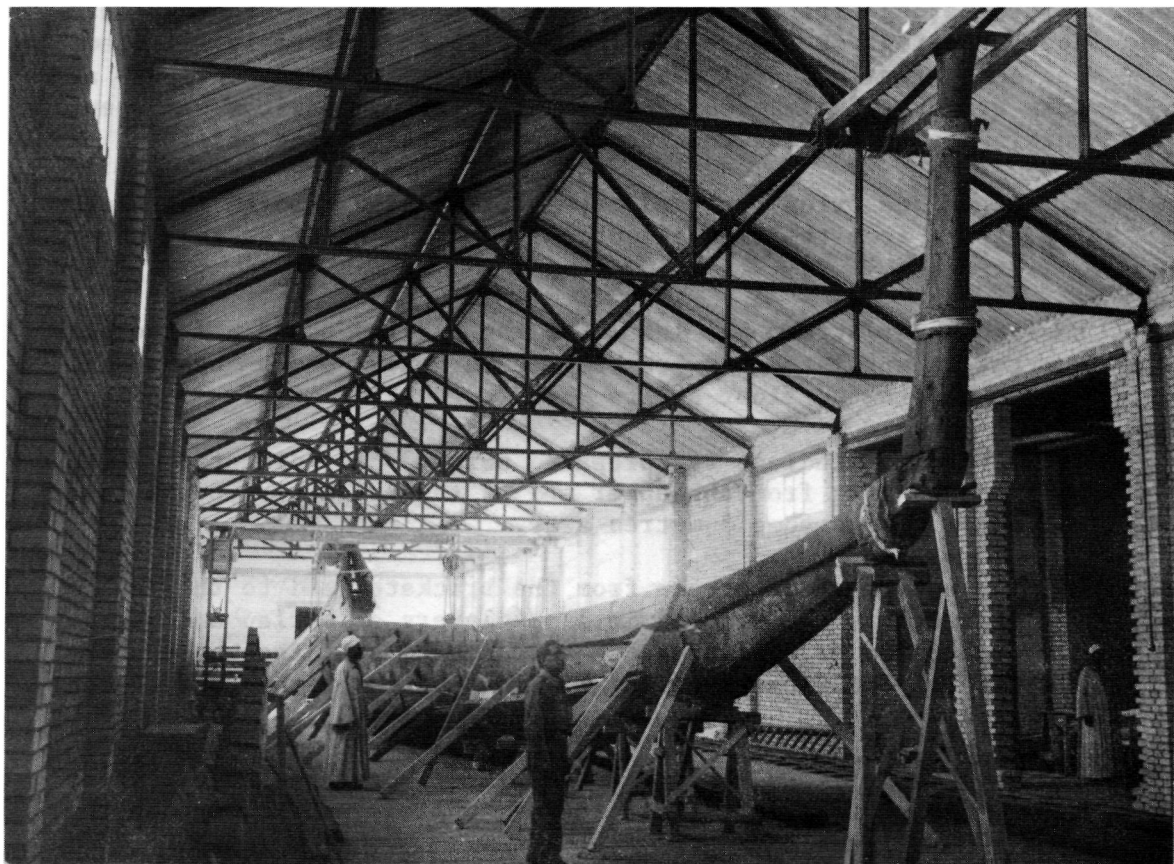
6 deck beams	Layer 13 floor	N.A.	disintegrated or missing ²⁸	none
18 planks, all layers bottom planks, side longitudinal girders 3 frames, spine, 4 deck panels, 3 deckhouse roof panels, battens		Fig. 39	warped, twisted and distorted. On average dis- tortion in the timbers was less than 20cm. in timbers up to 23m in length	compression, changes in pit's temperature and relative humidity over time.

39. Reconstruction 1, starboard side showing distorted sheer strake, and many shores holding planking in place.

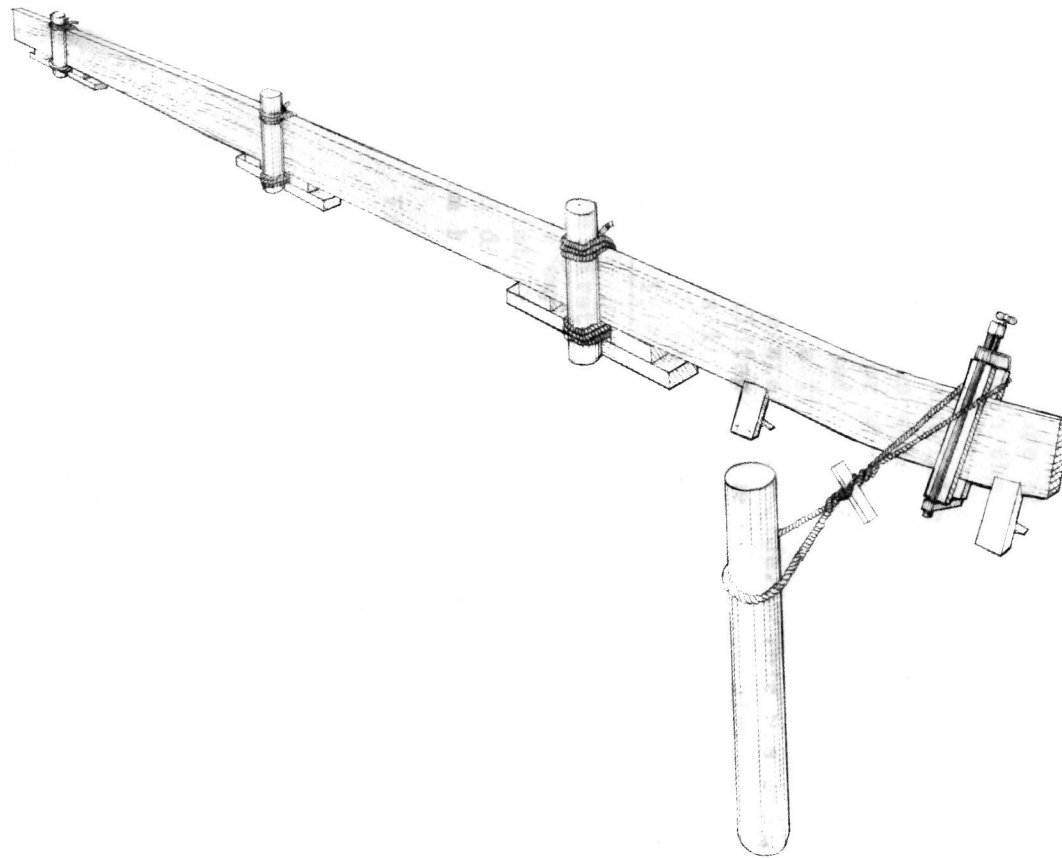
40. The sheer strake lashed in place with a Spanish windlass set up for de-twisting. Peter Schmid/Paul Lipke.

- E. The brackets were removed, and the Spanish windlass was moved from the end to a section needing more curve.
- F. Windlasses were run to any other areas needing more curve, shores were set up, and hot water and pressure were applied as in "D" with incremental changes averaging 1 cm. per day.
- G. In all cases, twist was adjusted first and curve second.
- H. With realignment complete, the burlap was removed, the timber released from the bending jig, PVA reapplied and the timber replaced in the ongoing reconstruction.
- I. "90% of the reshaping was done in this way. The last 10% (2. to 3. cm. of corrections) were made with the timbers in place on the ship. This was done without boiling water
