The Royal Ship of Cheops

A retrospective account of the
discovery, restoration and
reconstruction.

Paul Lipke

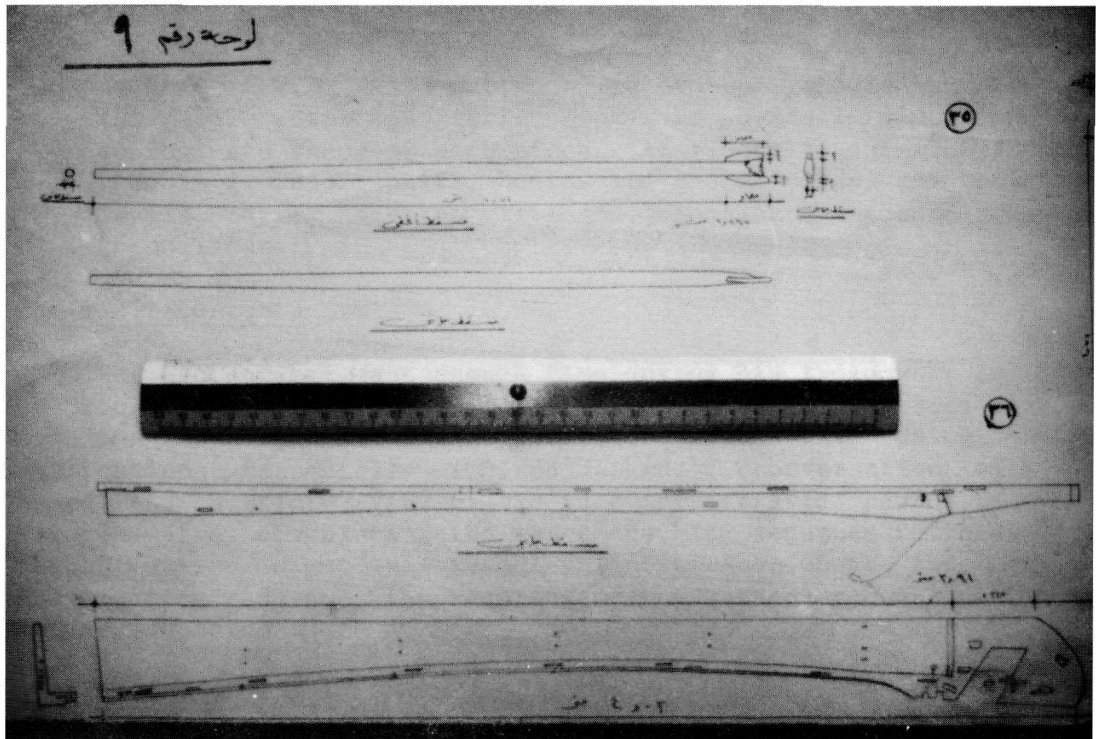
9. Pieces no. 35 and no. 36; Hag Ahmed calls no. 35 (top) a boat hook. For both pieces section views are very limited, the stern backing timber cover (no. 36 bottom) also lacks records of bevels.

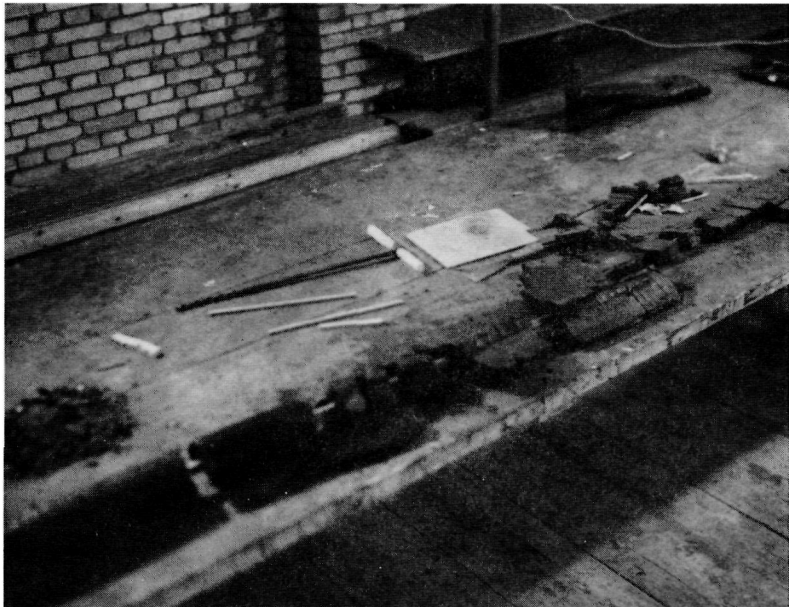
22. Fragmented oar bored for aluminium rod. Note auger, pile of wood dust, tiny fragments, and slivers of ennab for fragment alignment.

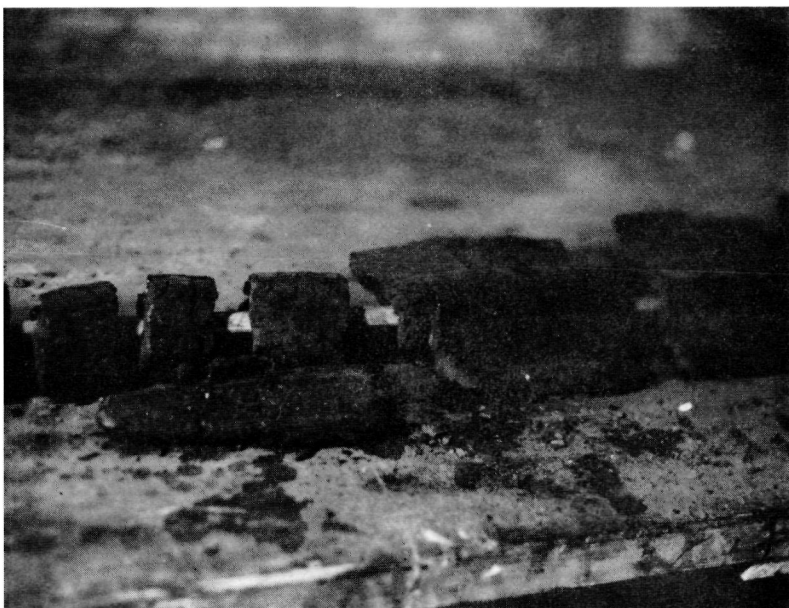
23. Oar fragments arranged on the rod. Note extreme desiccation.

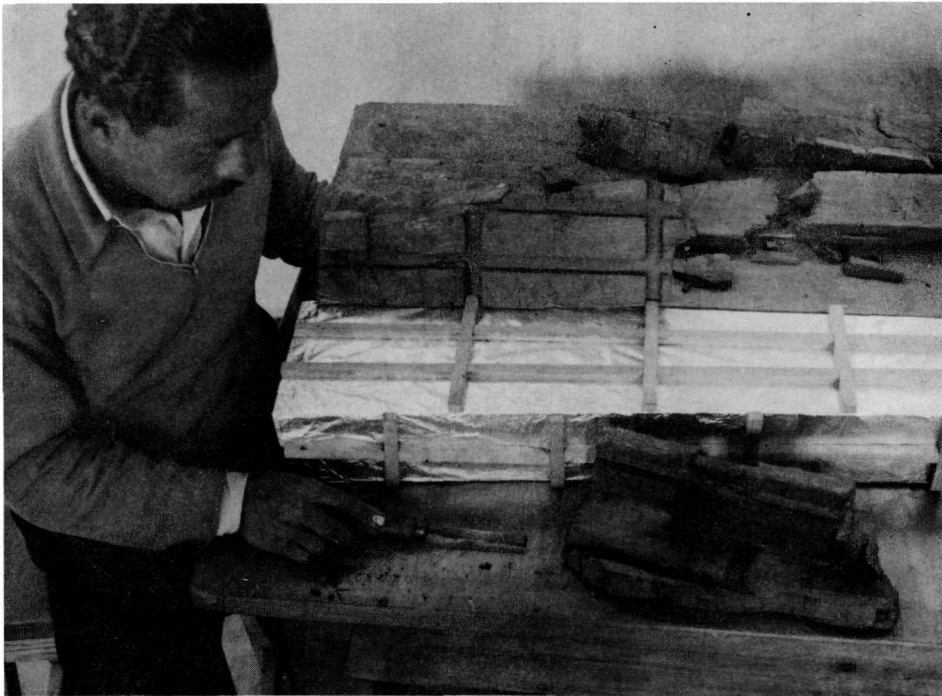
26. Backing timber cover; detail of dadoed fragments and mould.

All four of the "L" shaped forward backing timber covers and two of the six aft covers needed restoration upon excavation and some were restored twice more during the 1960's (Fig. 41). The example shown is the forward, port, upper cover.

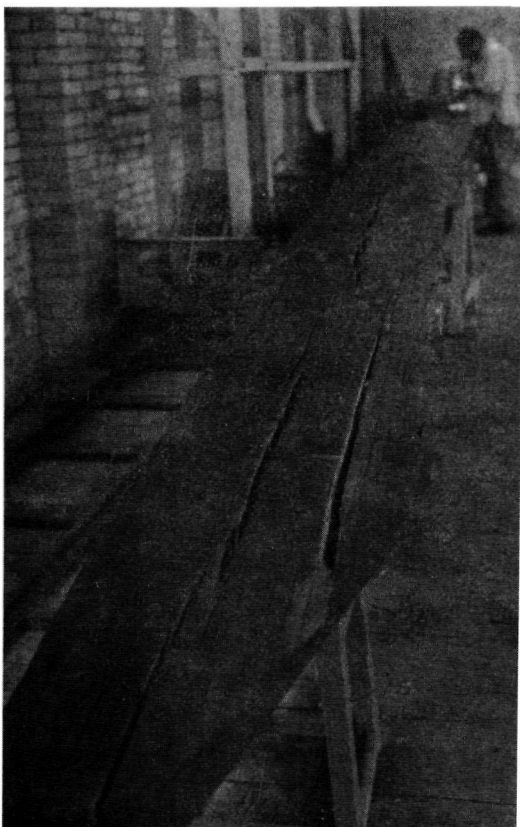
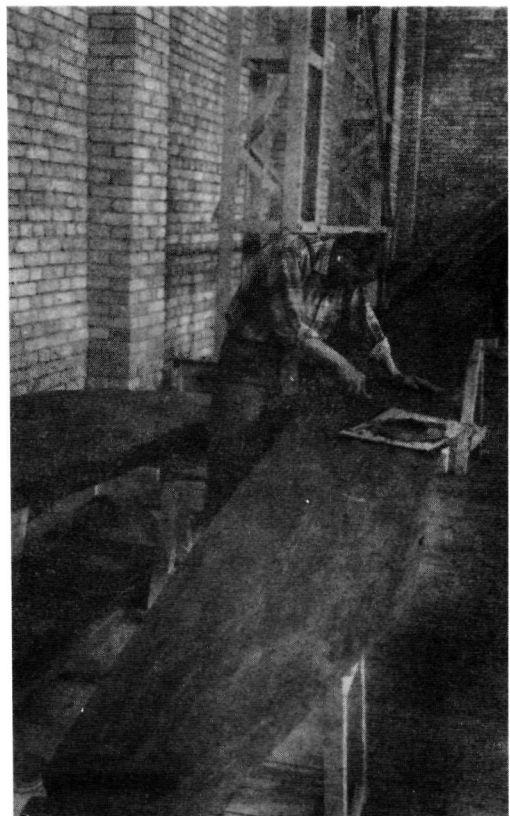
32. Extreme checking of a plank; one end of the right hand check partially filled with paste.
33. Plank with all checks filled receiving final touch up with paste before application of hassagōz.

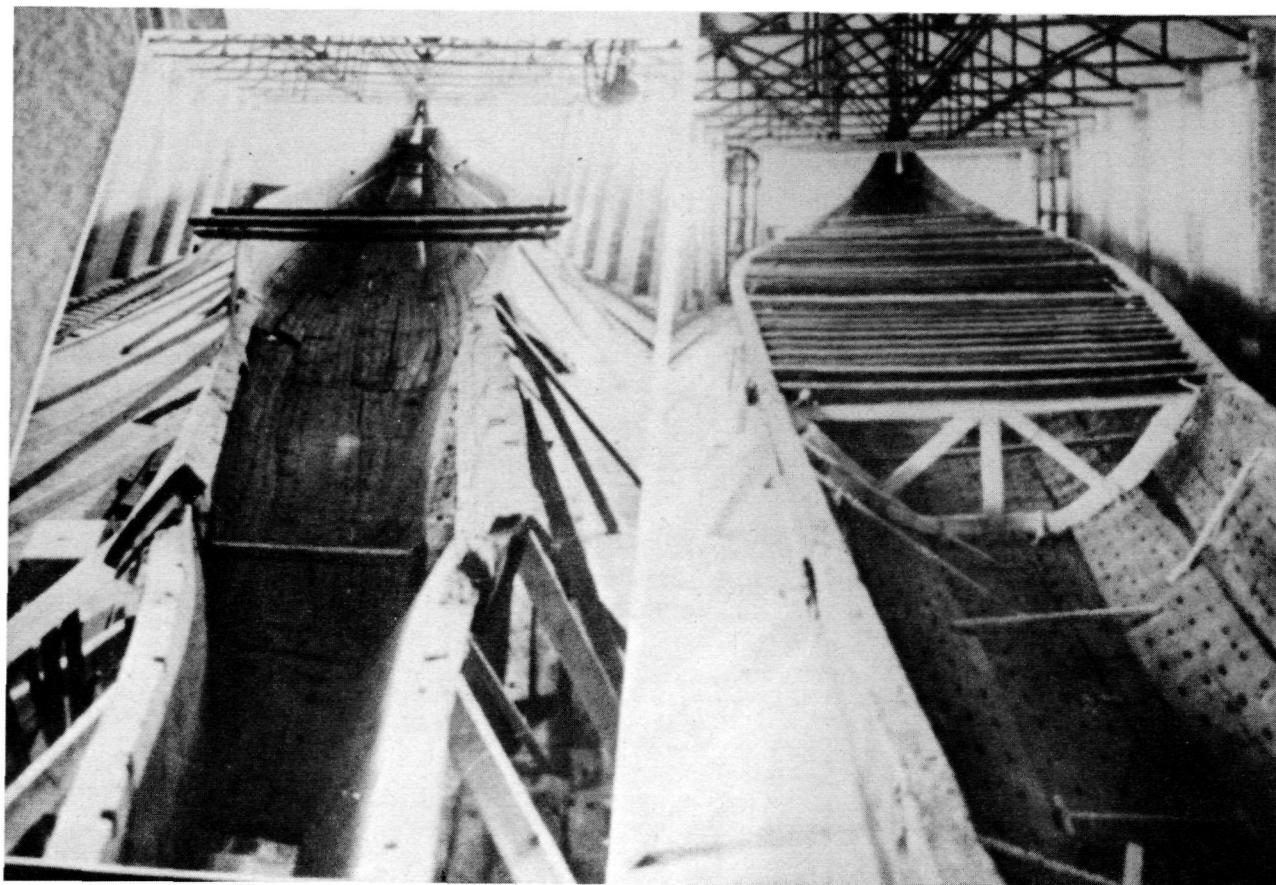
I thought the deck beams would be very easy to locate since the sheer strake was so clearly notched to receive them. But, when we took the longest of those beams and tried to place them in the midships notches of the sheer strake it was clear that the hull was too narrow - too narrow by as much as 68 centimeters! (Fig. 45). It was a big problem and I could not see a straight forward solution to it at the time. I decided to

45. The deck beams made Hag Ahmed aware of the discrepancy between the second reconstruction and the ship's original beam. Later, measurements taken at these points were used to build moulds. A.Y. Moustafa.
